3. INTERMEDIATE FIELD TEST 1

3.1 TEST 1 OBJECTIVES AND TEST PIT OVERVIEW

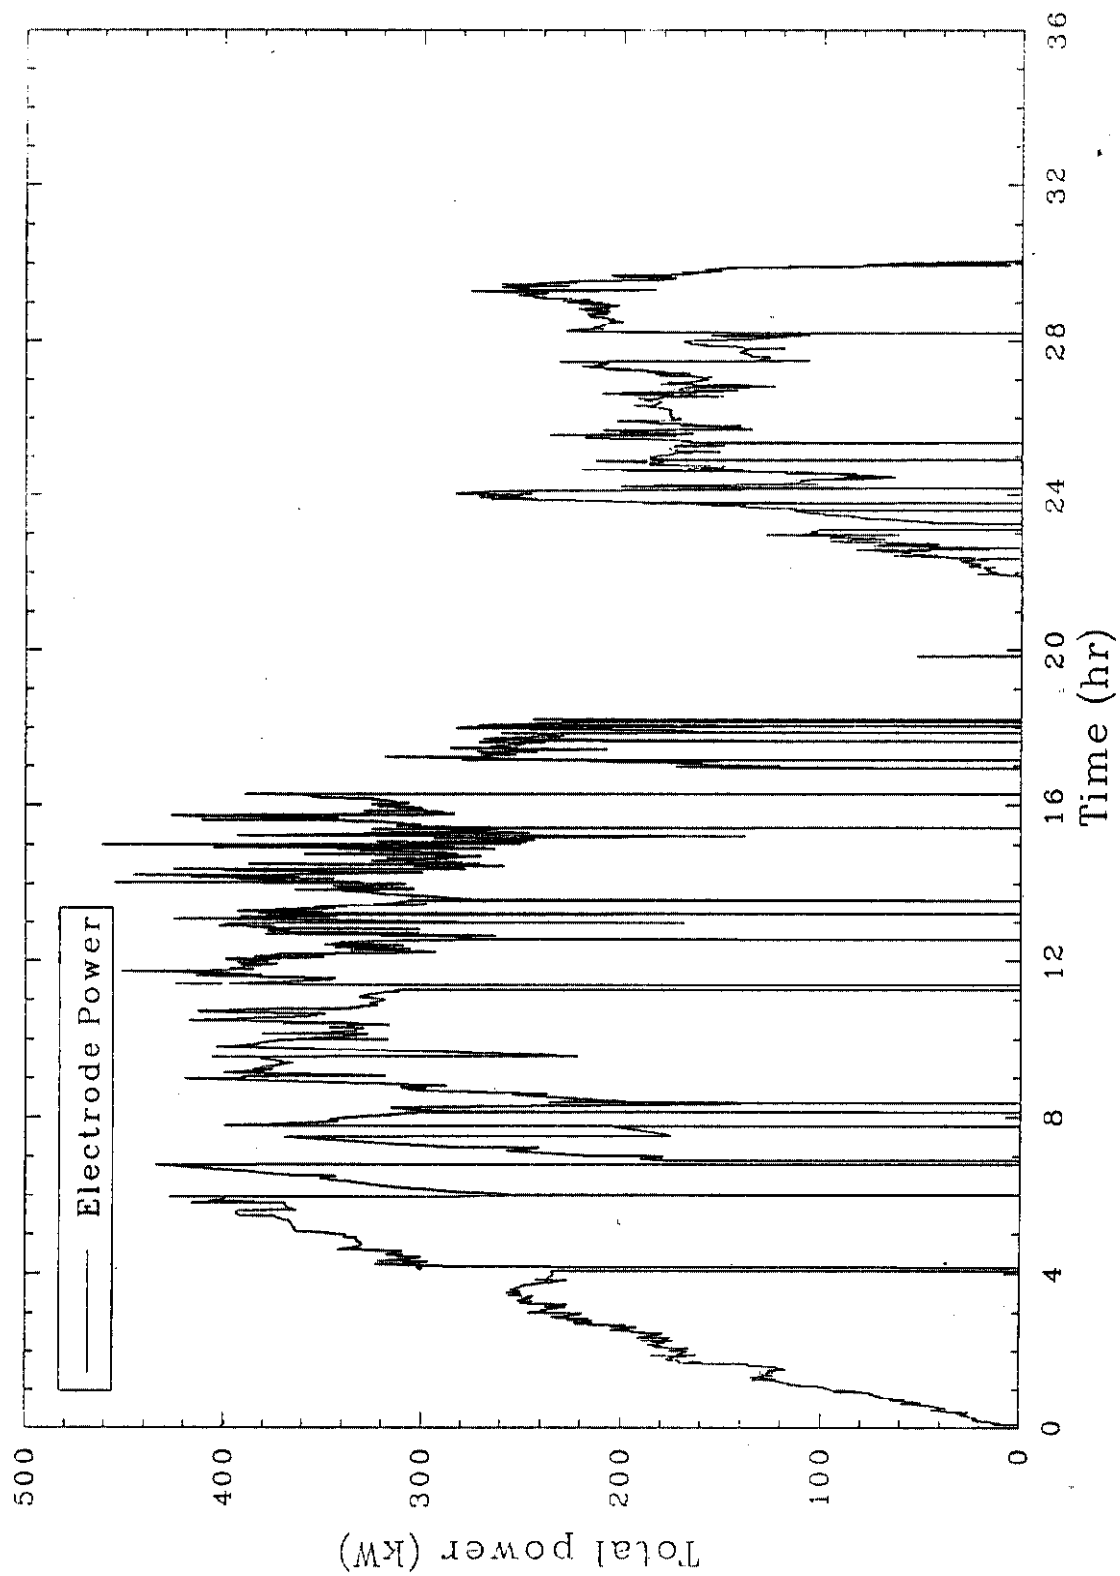
Test 1 was restarted at 16:13 hours on June 14, 1990. The power levels fluctuated during the test but generally averaged around 300 kW for the total test duration of approximately 18 hours and at the approximate total of 5400 kWh, as shown in Figure 16. Note that power is gradually increased over the first six hours to minimize possible disruptions in the starter path and to minimize the particulate generated by the oxidization of the graphite in the starter path. Hood plenum temperatures averaged around 300°C, which was slightly lower than predicted based on computer modeling. The lower-than-predicted temperatures were due to periods of nonpowered operations as a result of electrical imbalances associated with the power supply. Figure 17 illustrates the typical increase in resistance as the power distribution is transferred from the highly conductive starter path to the surrounding molten soil. As the molten soil zone grows, resistance decreases. The overall rate of downward melt growth averaged 4.6 cm/h (1.8 in./h), as illustrated in Figure 18. This average rate includes the final 15 hours of operation during which the downward melt growth rate was severely reduced due to the electrical imbalances described later in this report. The achieved melt depth was approximately 2.4 m (8 ft). Subsidence was measured at approximately 1.4 - 2.0 m (4.5 - 6.5 ft), leaving a 0.4 m (18 in.) layer of glass in the bottom of the vitrified area.

Figure 16. Total electrode power for Test 1.

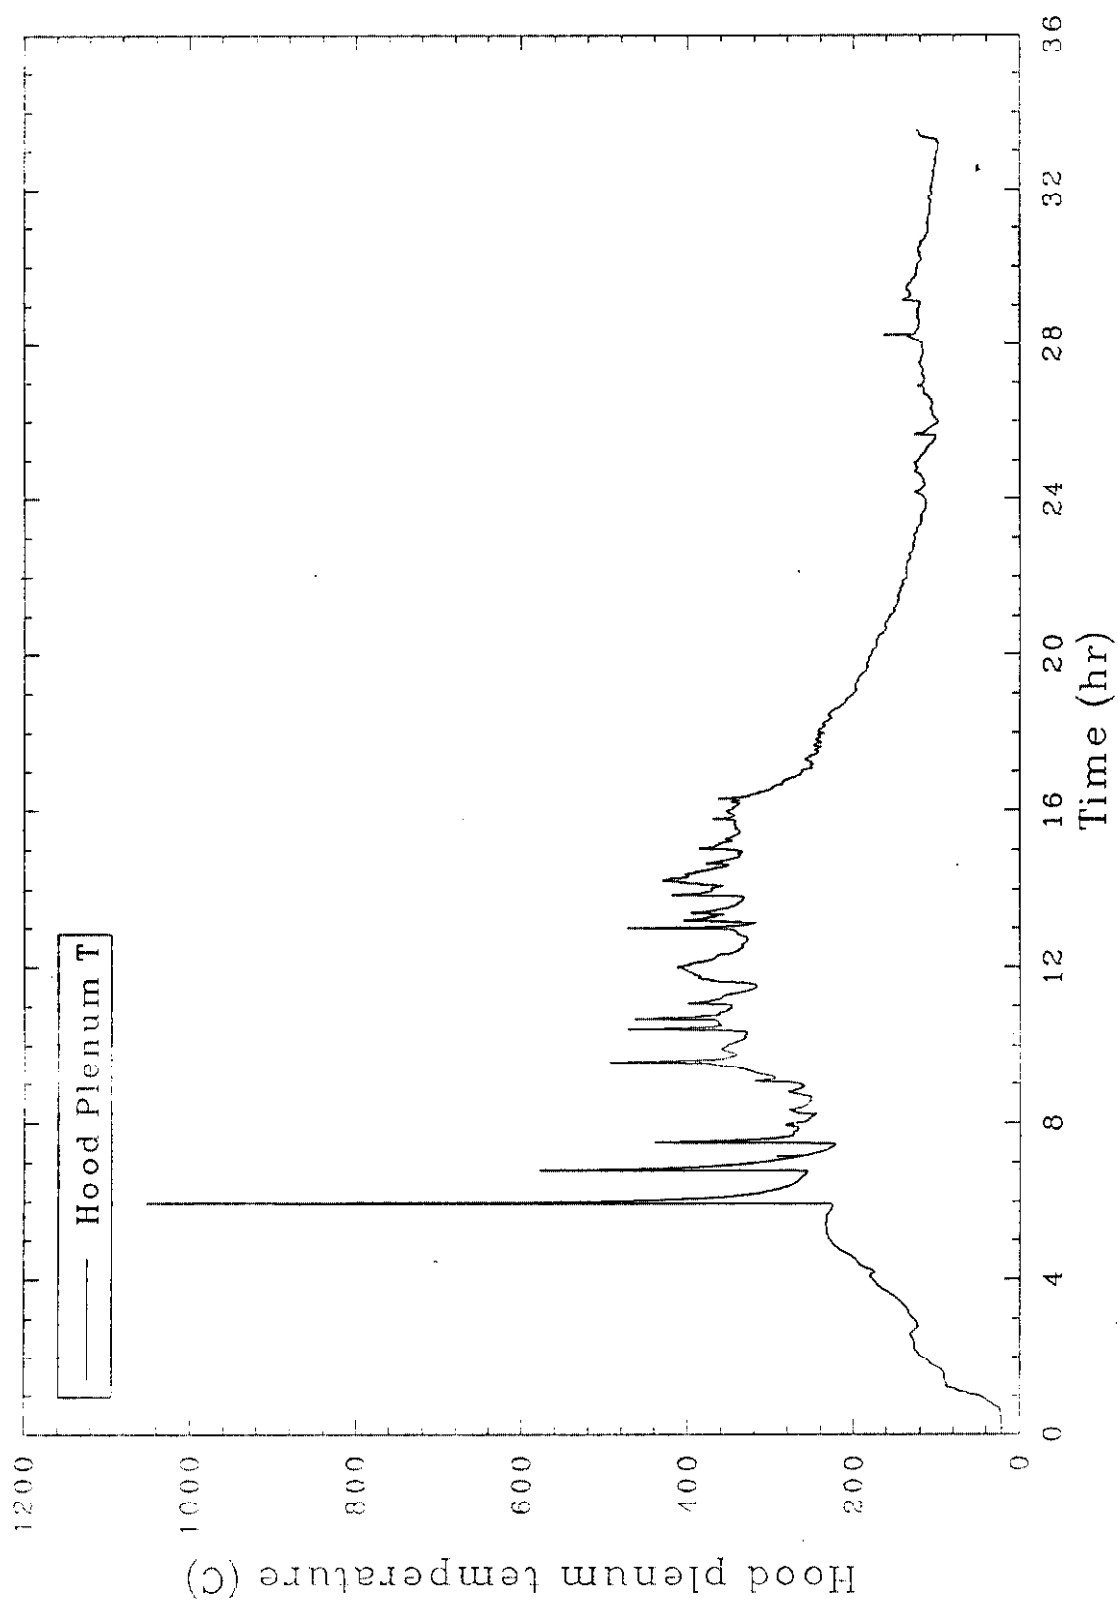
The first intermediate-scale test of a simulated buried waste site resulted in a dynamic process, especially regarding conditions in the melt and off-gas hood. Surges in off-gas generation rates resulted in a loss of hood vacuum on several occasions; however, the hood was maintained at an overall average between 1.0 and 1.5 in. of water vacuum, and the plenum temperature maintained at an average of 300°C. Plots of the hood vacuum and the plenum temperature for the entire test are provided in Figures 19 and 20. A total of 14 significant temperature spikes were recorded, resulting in a net temperature increase ranging from approximately 50°C to over 300°C, as shown in Figure 20. The initial temperature spike in Figure 20 is biased high because this first event was observed to result in molten glass splashing up onto the tip of the plenum thermocouple. Other thermocouples in the hood suggest a true plenum temperature of approximately 700°C. The plenum temperature was generally the hottest temperature recorded in the hood because it is in the center of the hood cavity and was nearer to the molten glass than other thermocouples. Because the hood plenum thermocouple was not shielded from radiation, it is likely that radiant heat transfer was biasing these temperature values higher than true gas temperature. As shown in Figure 21, the cooler hood, roof, and wall temperatures parallel the plenum temperature.

Figure 20. Hood plenum temperature plot showing temperature spikes for Test 1.

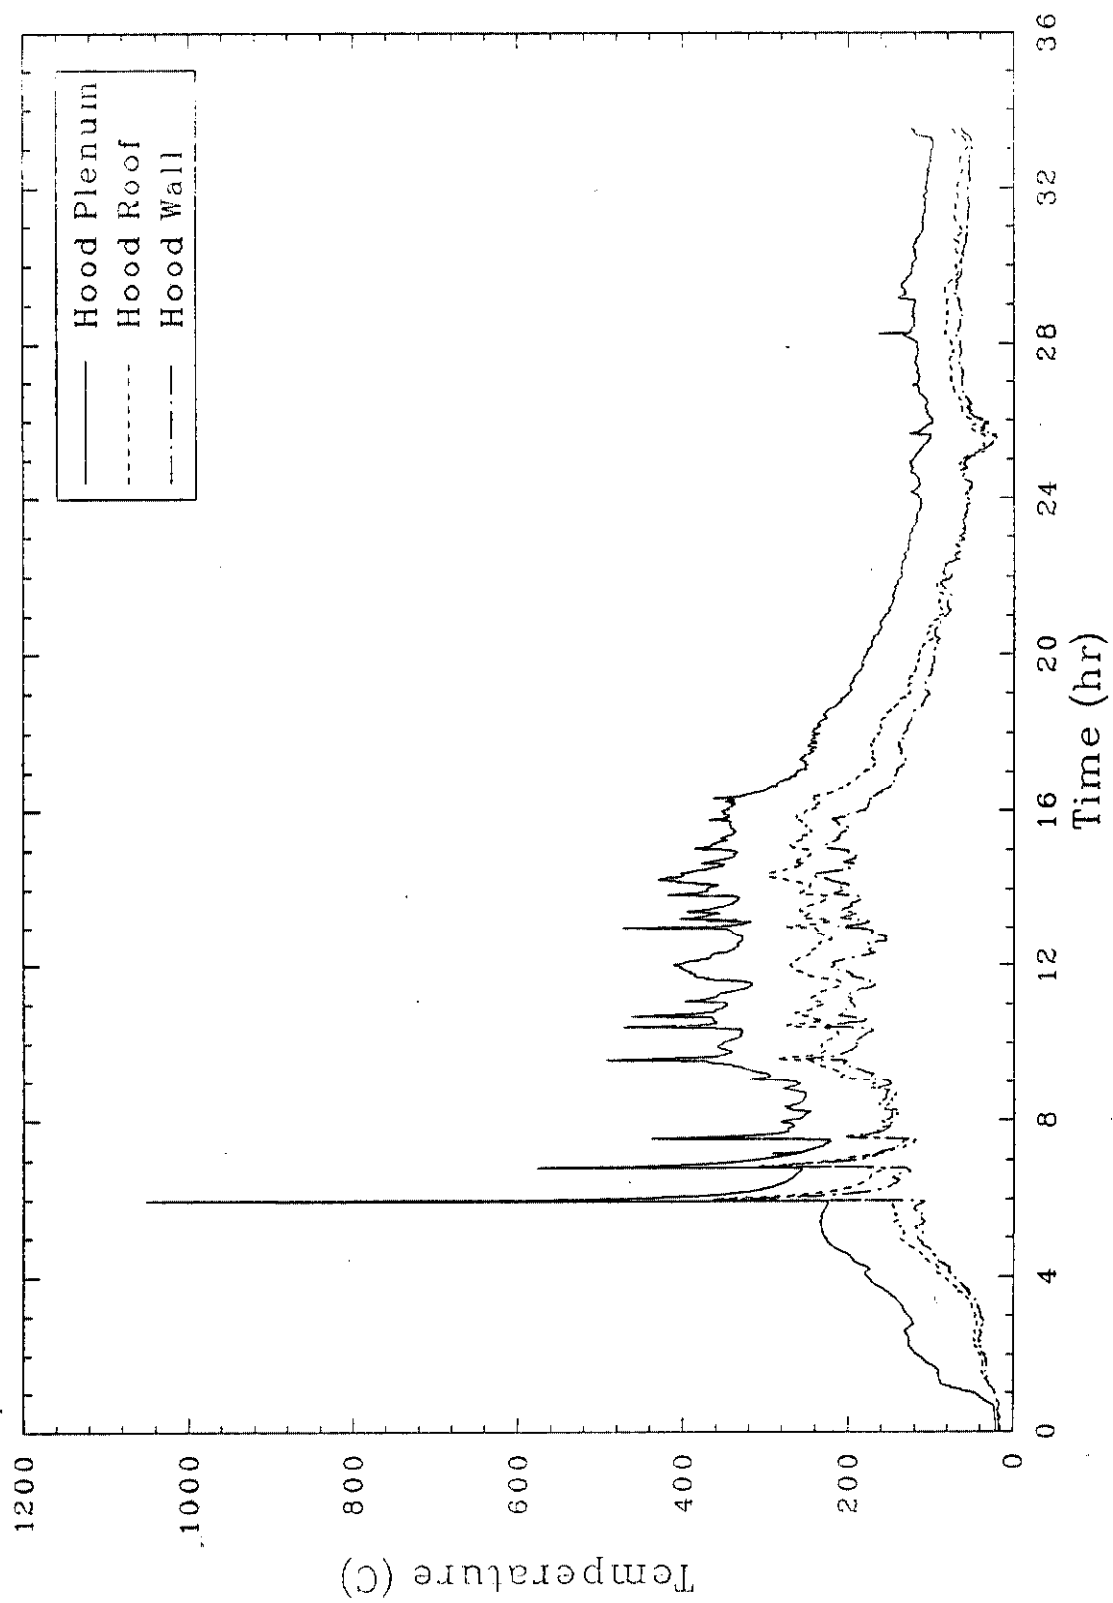
Figure 21. Hood Plenum, roof, and wall temperatures for Test 1.

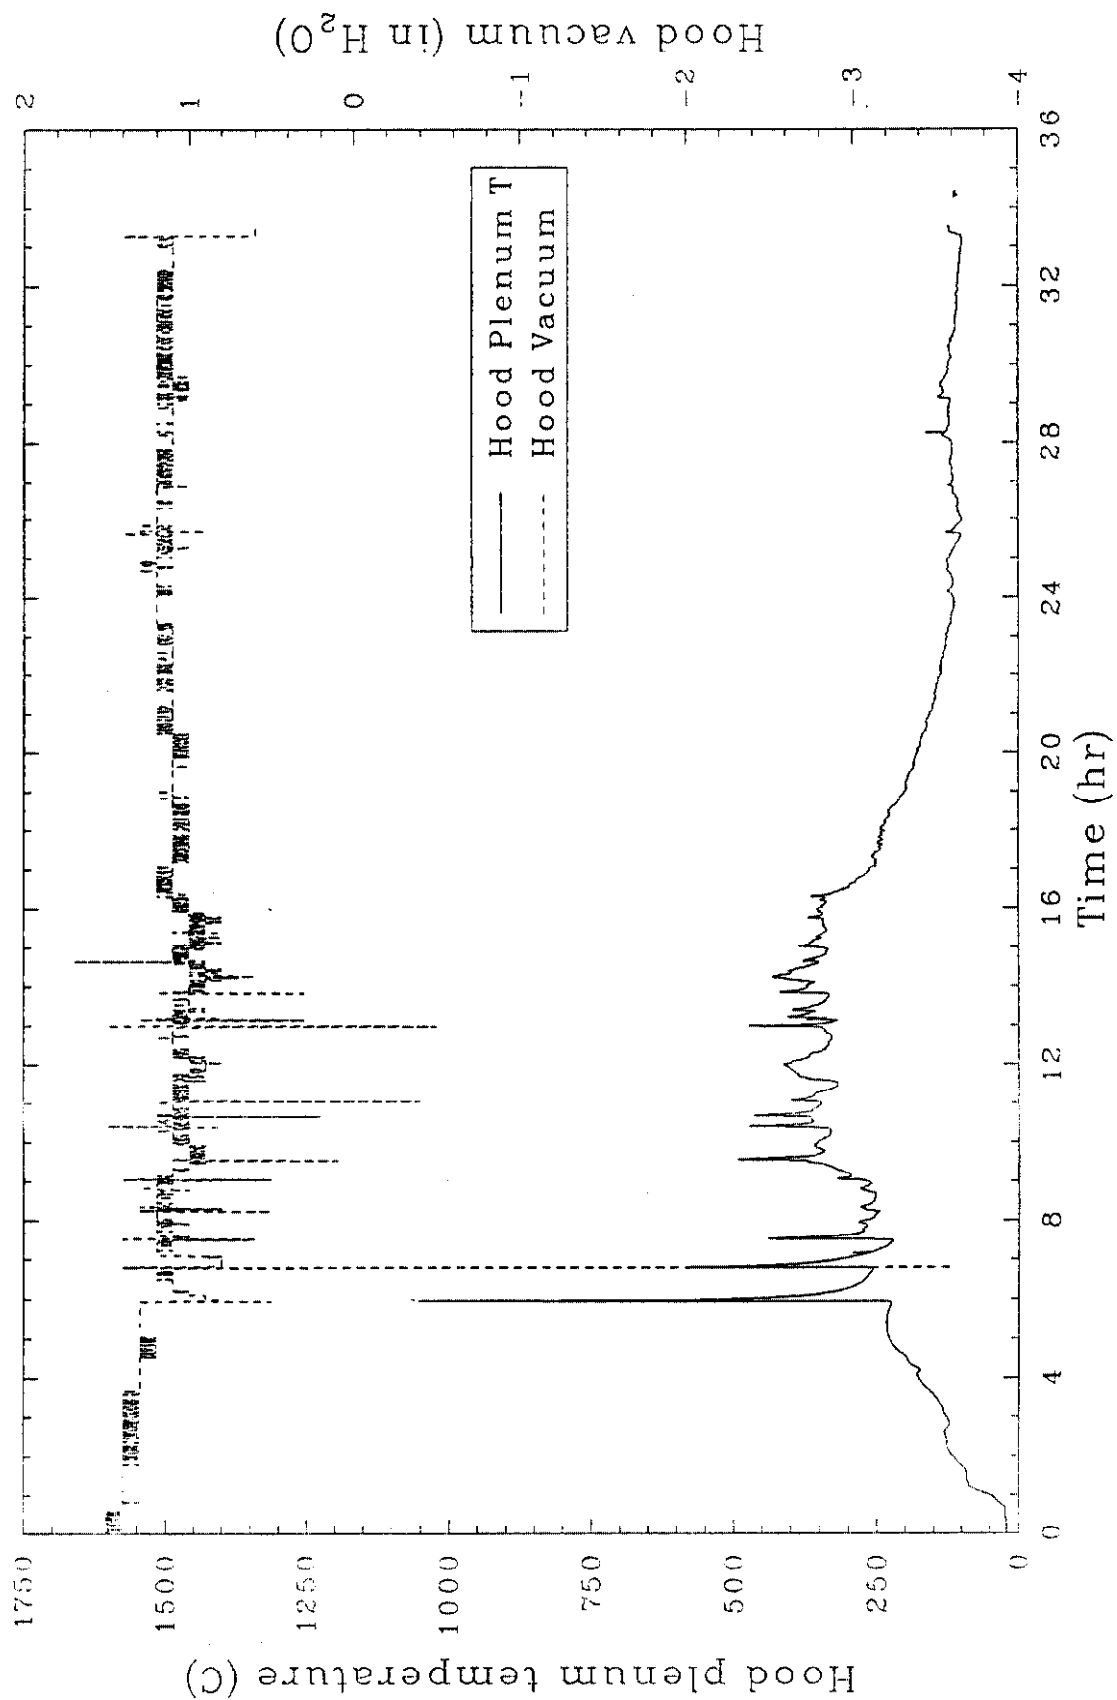
Figure 22. Hood vacuum and plenum temperature for Test 1.

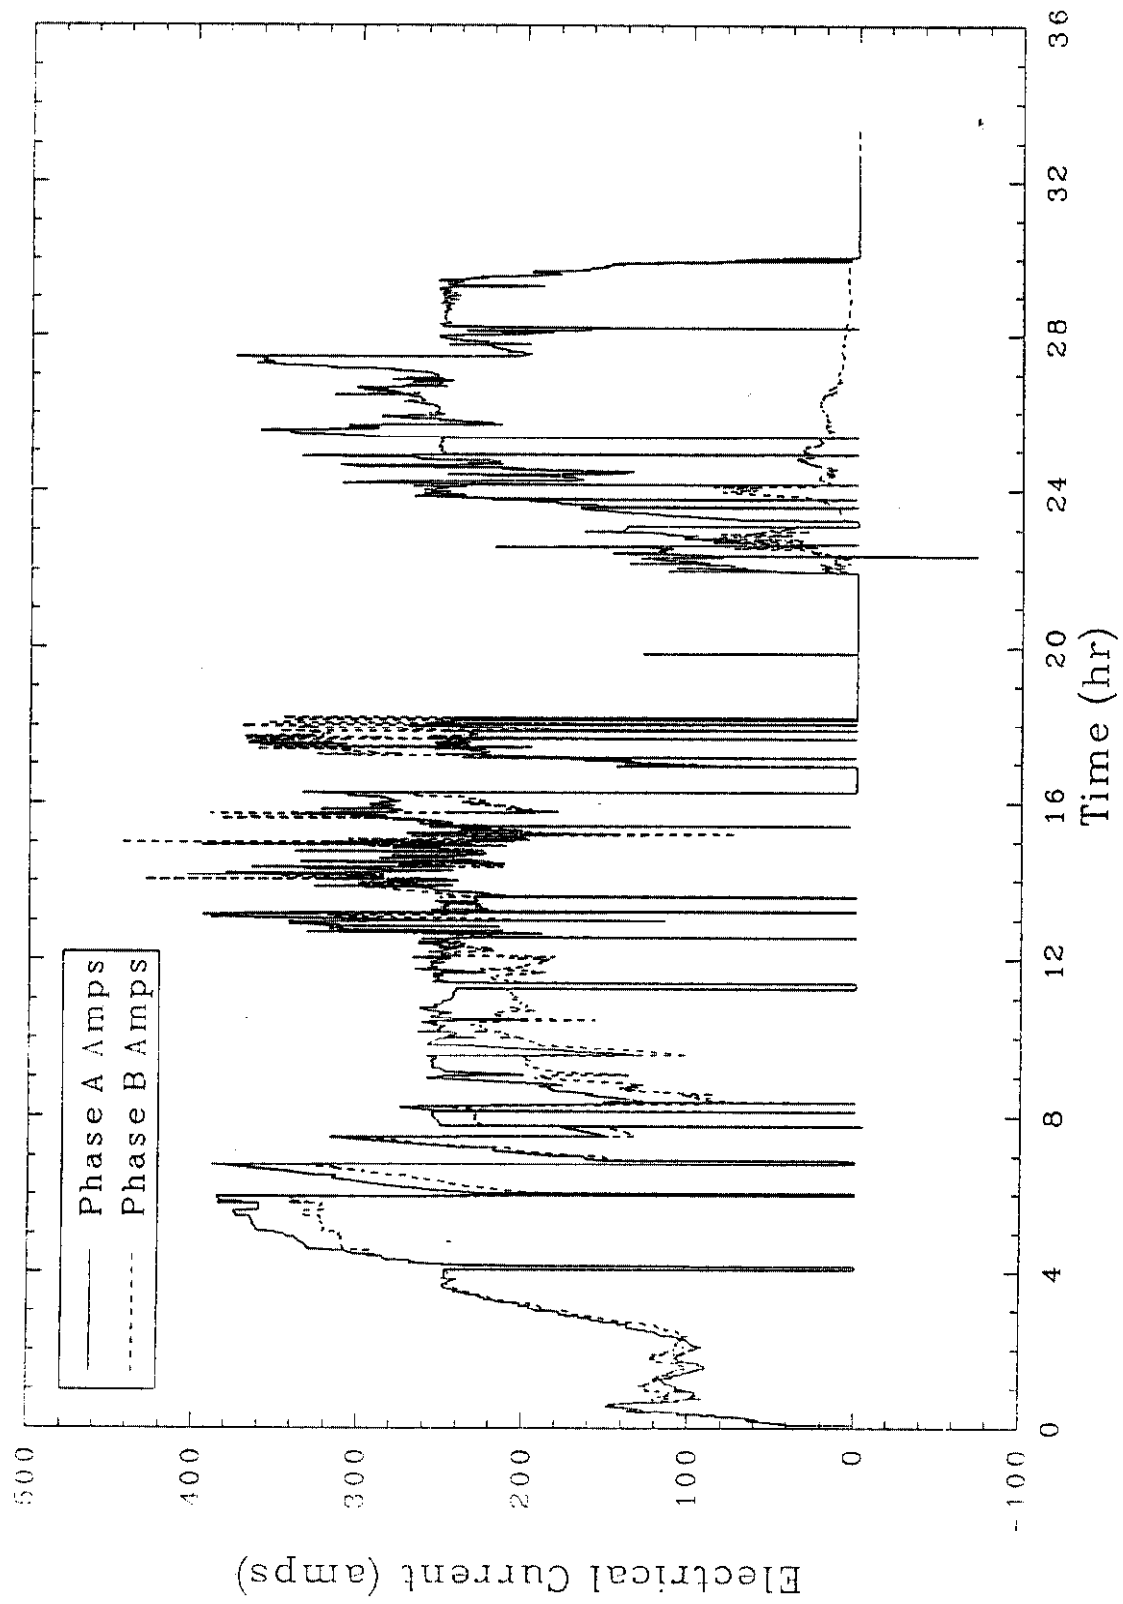
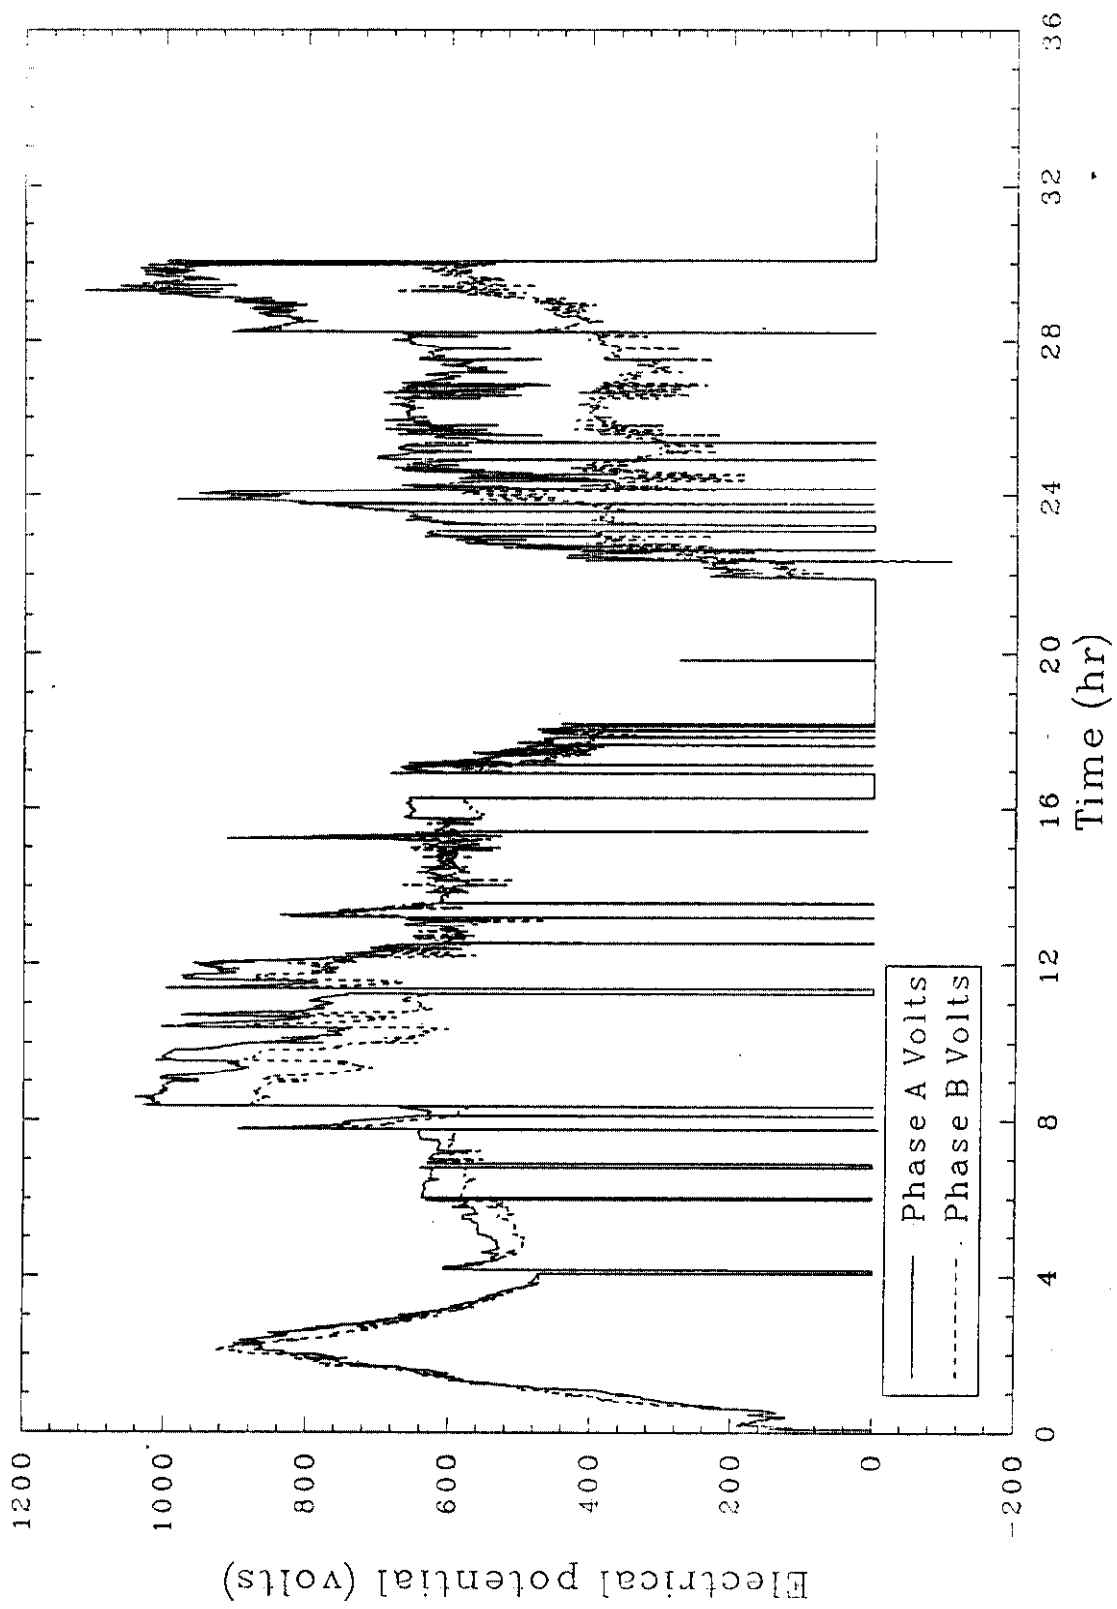
Test 1 resulted in a total power level that varied typically between 300 and 400 kW. Plots showing amperage and volts for each phase are provided in Figures 24 and 25.

Figure 24. Phases A and B amperage for Test 1.

Figure 25. Phases A and B voltage for Test 1.

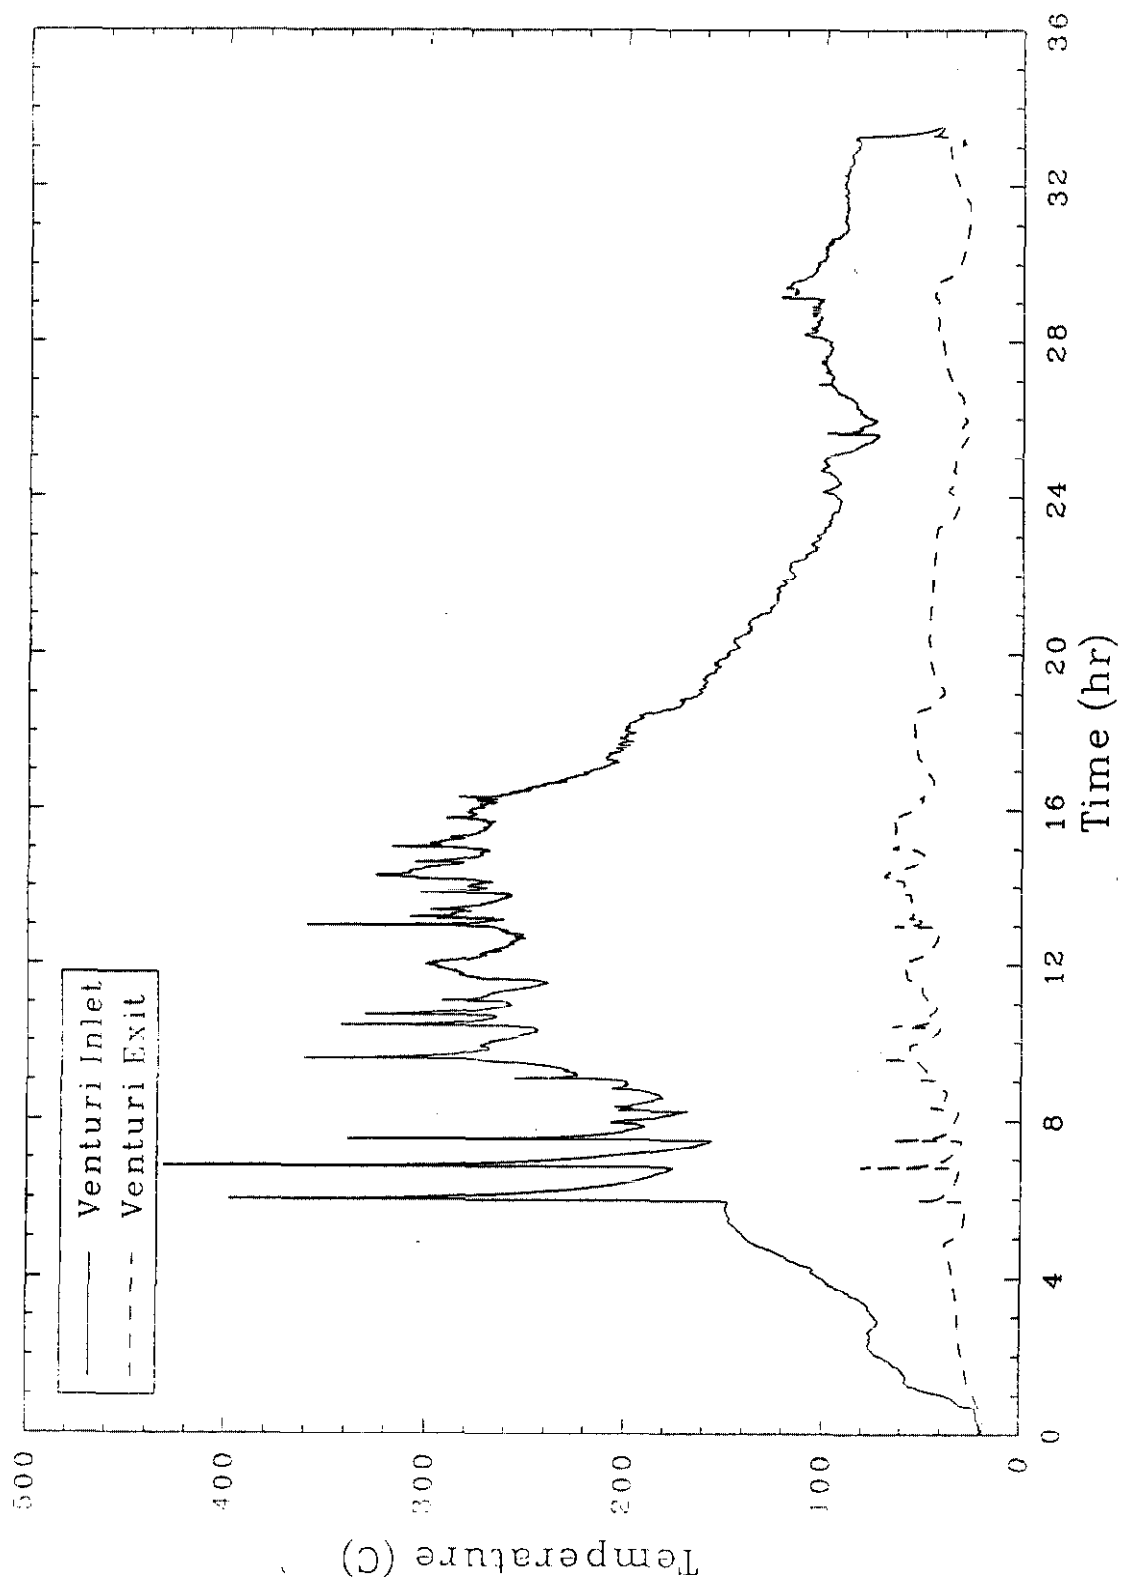
The performance of the Venturi-Ejector relative to heat removal is illustrated in Figure 26, which shows the gas temperature entering the Venturi-Ejector typically ranged from 200 to 300°C. The exit temperature (Hydro-Sonic entrance) was typically less than 50°C. Fluctuations in differential pressure for the Venturi-Ejector, shown in Figure 27, were due to corresponding hood vacuum fluctuations. The pressure on the upstream side of the Venturi-Ejector was measured on the off-gas line that was directly affected by fluctuating hood vacuums.

Figure 26. Temperature at inlet (off-gas at trailer) and exit of Venturi-Ejector for Test 1.

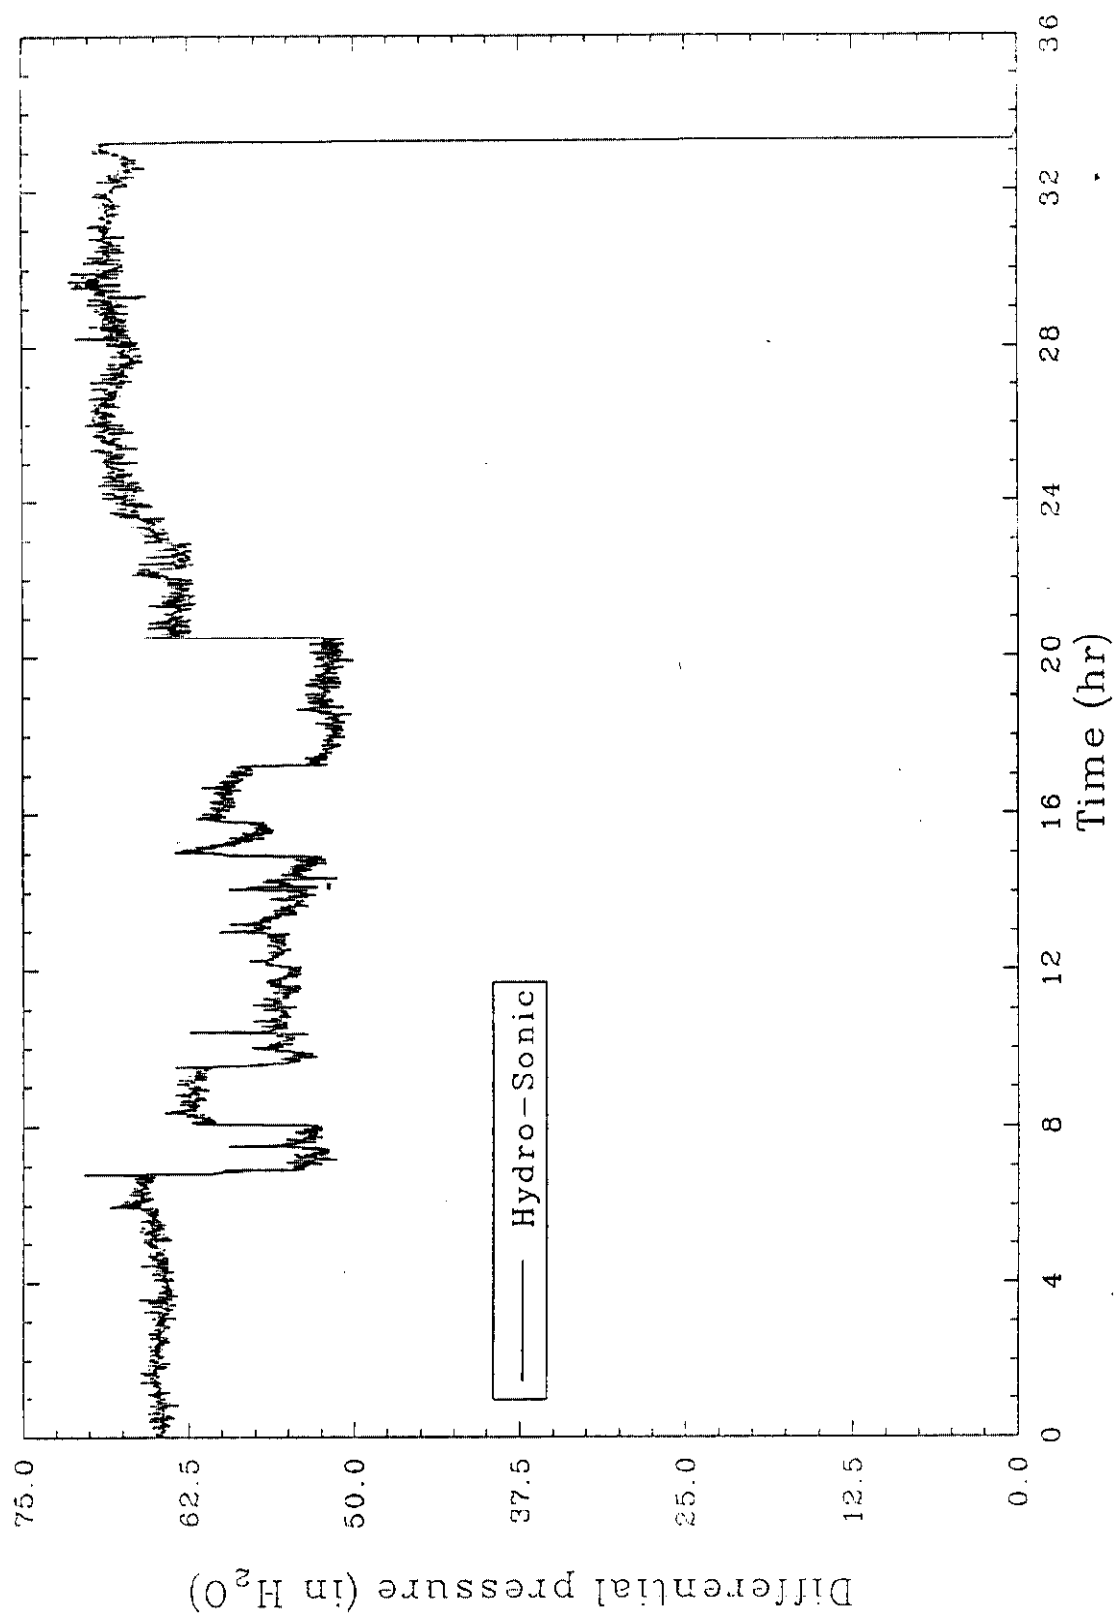
The Hydro-Sonic scrubber differential pressure was maintained well above 50 in. of water throughout the test, as shown in Figure 28. By design, this should have resulted in a particulate removal efficiency of greater than 90% for particles sized greater than 0.5μ . The fluctuations of differential pressure were due to fluctuations in total off-gas flow created by the automatic adjustment of the blower surge protection valve.

Figure 28. Hydro-Sonic scrubber differential pressure for Test 1.

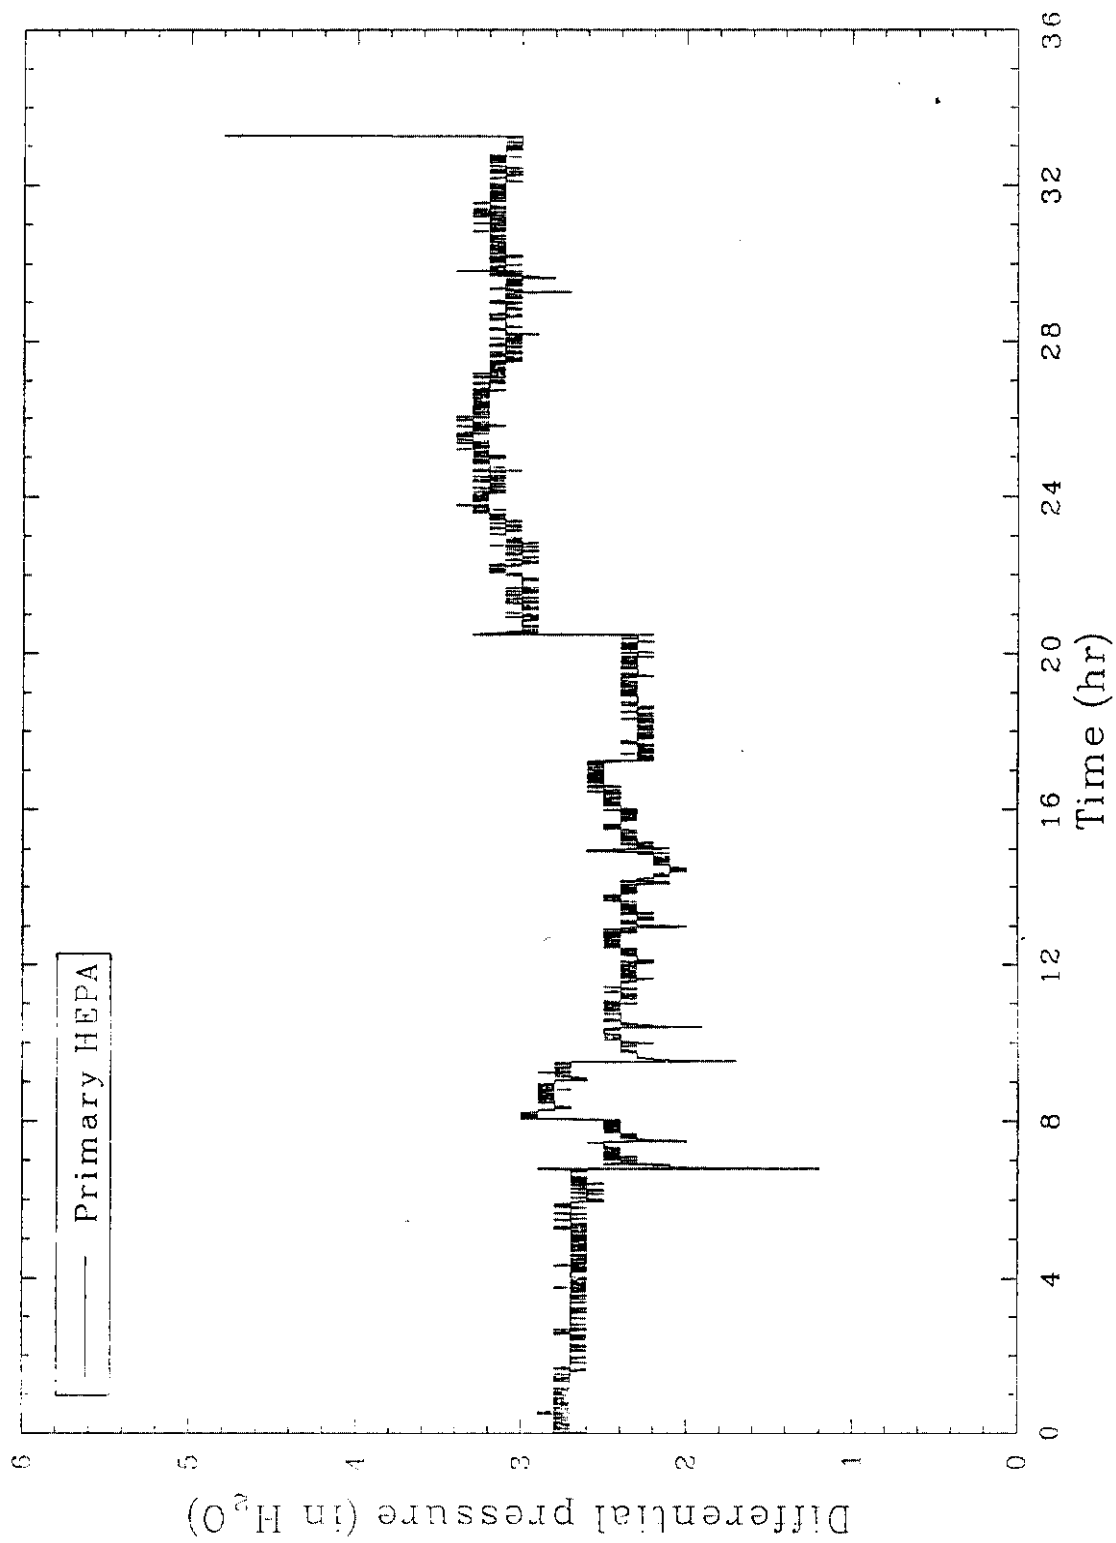
Differential pressure measured across the housing of the primary HEPA filter is shown in Figure 29. The differential pressure remained relatively constant throughout the test, indicating the scrubbers effectively removed the vast majority of particulate. Thus, a large-scale machine with a wet scrubbing system of comparable design could sufficiently remove particulate from the off-gas stream.

Figure 29. Primary HEPA differential pressure for Test 1.

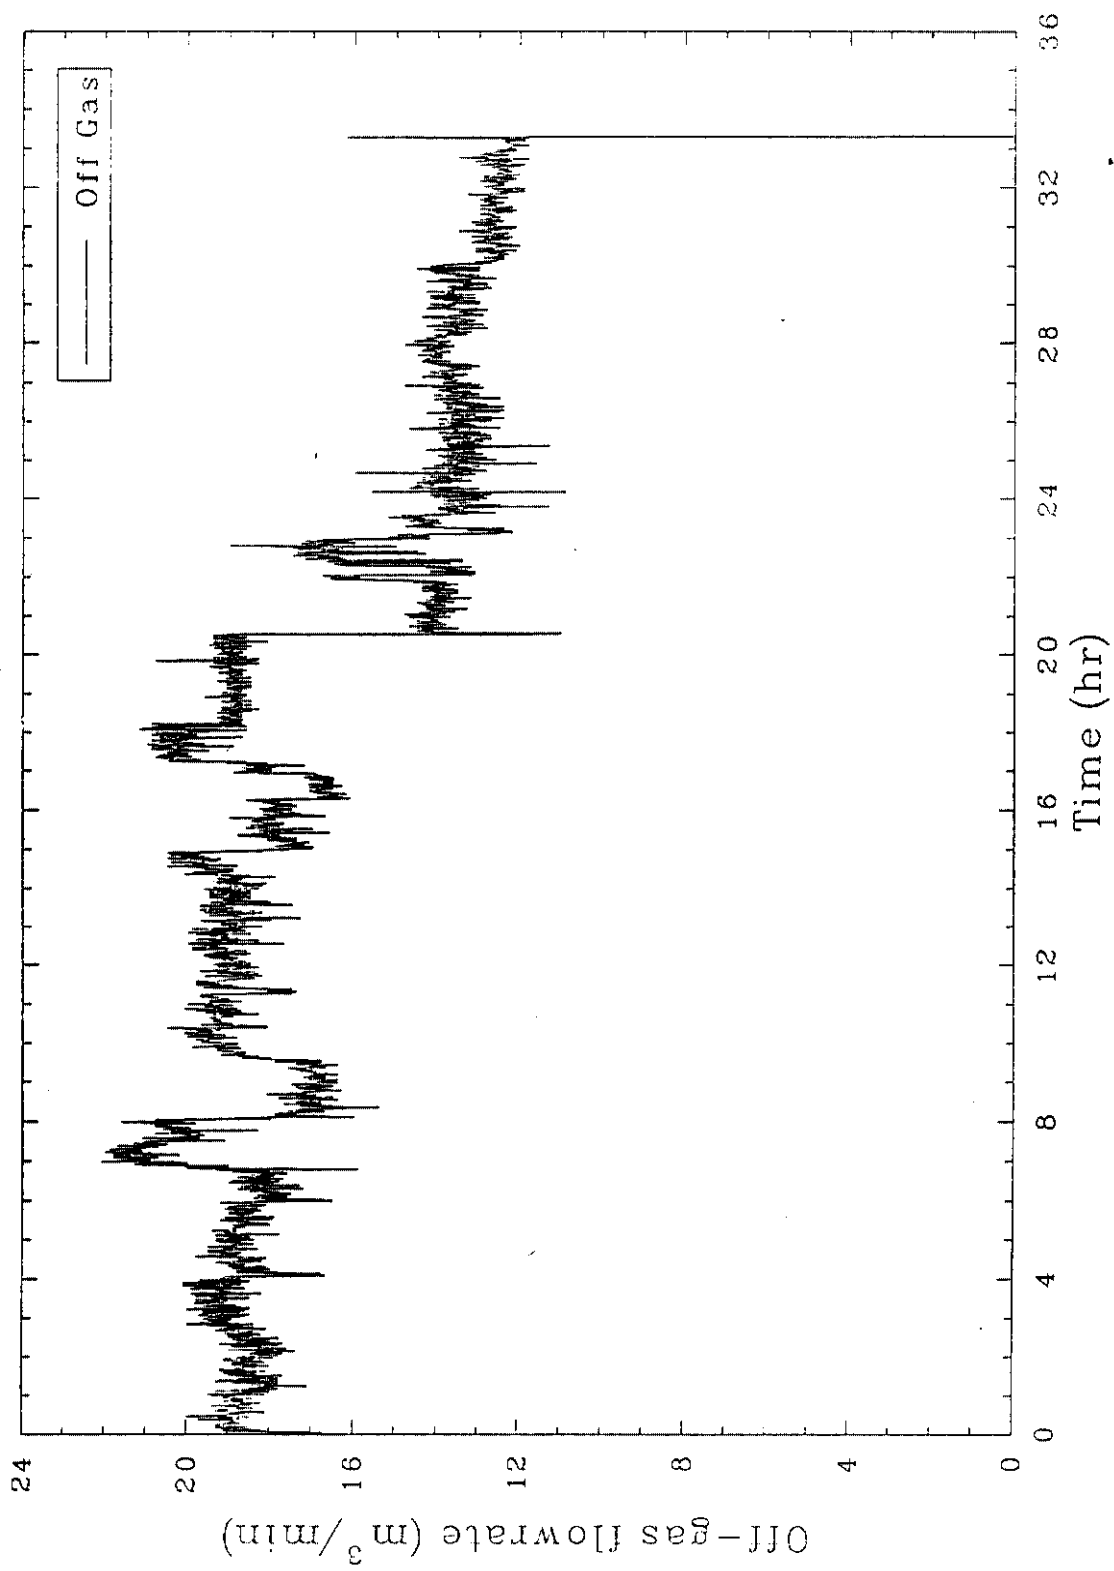
Total gas flow through the off-gas treatment system is shown in Figure 30. Total flow ranged from 12 to $22 \text{ m}^3/\text{min}$; however, periods where total off-gas flow exceeded $20 \text{ m}^3/\text{min}$ coincided with the blower surge protection valve being opened, resulting in a false high reading. Later in the test, after 20 hours, off-gassing from the melt decreased due to the lower power input related to transformer imbalances. At the time the off-gas system was shut-down (approximately 3 hours after electrode power was terminated), the off-gas flow had decreased to approximately $12 \text{ m}^3/\text{min}$. Because off-gassing from the melt at this point in time would have ceased, this flow rate is largely the controlled in-leakage of air into the hood.

Figure 30. Total off-gas flow rate for Test 1.

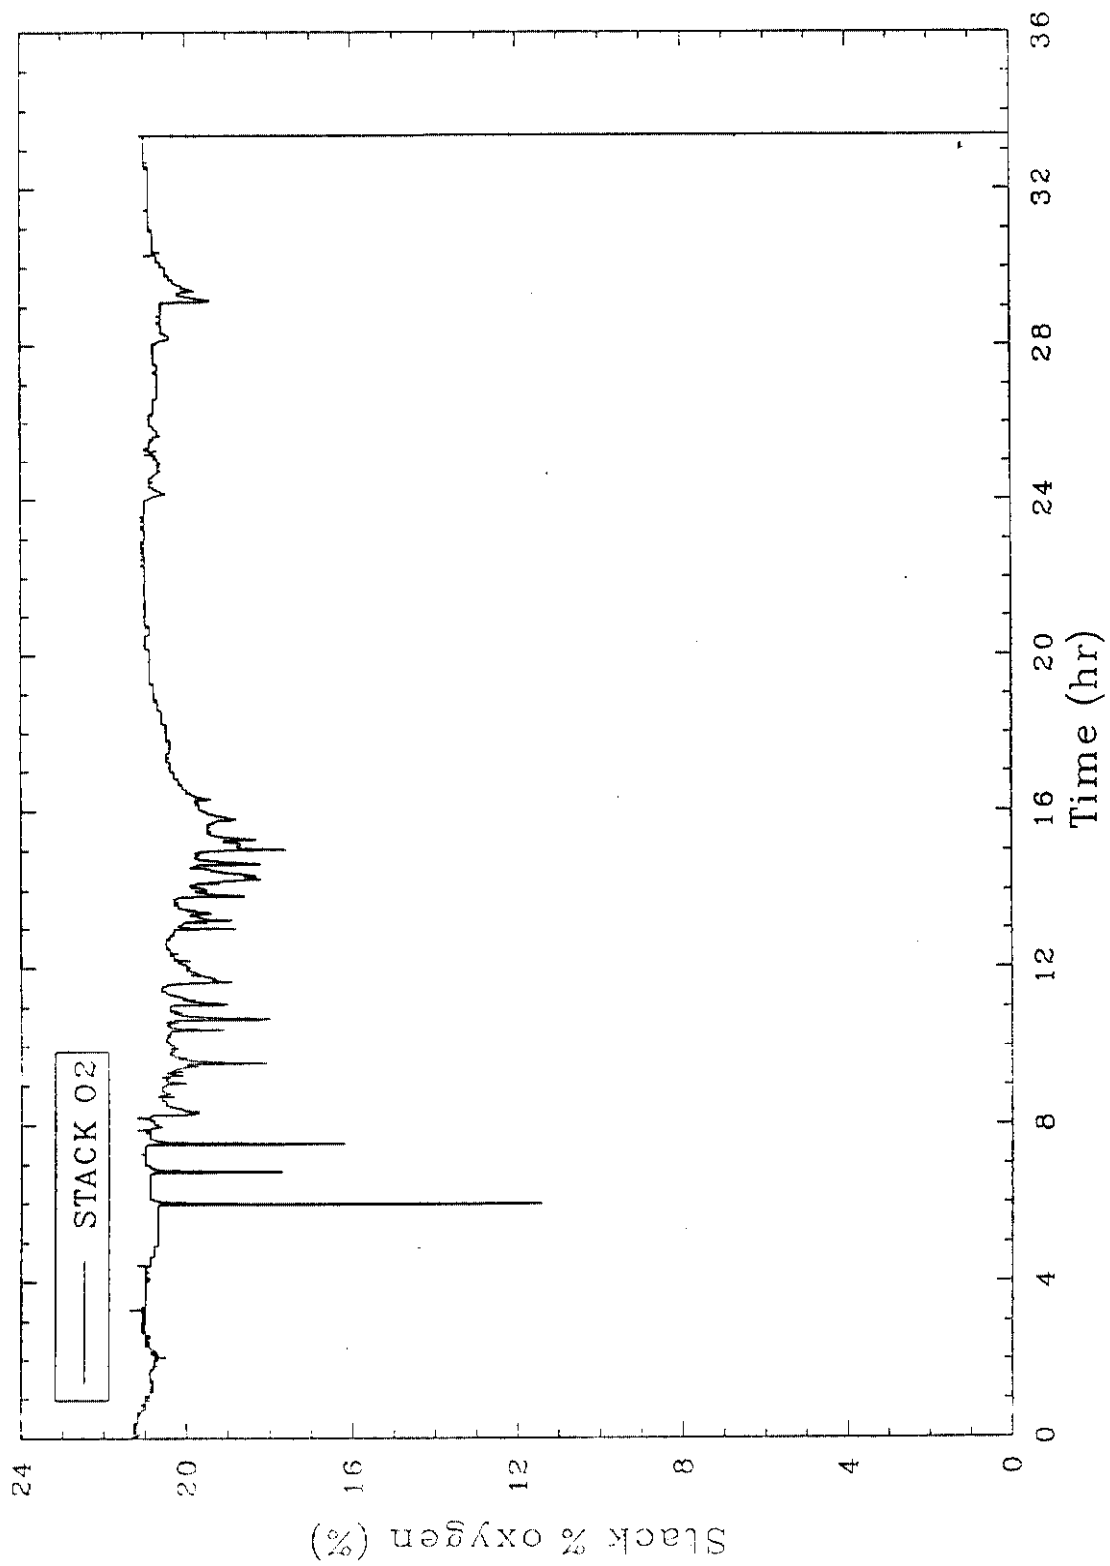
Concentrations of oxygen and carbon monoxide were monitored at the off-gas stack throughout the test. The oxygen concentration averaged between 20 and 21%, as can be seen in Figure 31. Short periods of reduced oxygen concentrations were measure at time periods consistent with gas releases from containers. This was consistent with the combustion of gasses in the hood upon release from containers in the melt. Carbon monoxide concentrations at the stack fluctuated throughout the test corresponding to gas releases from the containers in the melt and combustion activity in the hood. As shown in Figure 32, carbon monoxide concentrations ranged from 0.1 to 0.4%, with occasional spikes greater than 0.4%, up to a maximum of 1.1% at startup. The greatest concentrations of carbon monoxide are expected shortly after startup

Figure 31. Stack oxygen concentration for Test 1.
